PENNSYLVANIA
STEEL DAM

NDI ID. No. 2A-00195
PENNDER ID. No. 63-63

PHASE I INSPECTION REPORT
NATIONAL DAM INSPECTION PROGRAM

GAI CONSULTANTS, INC.
570 BEATTY ROAD
MONROEVILLE, PENNSYLVANIA 15146
AUGUST 1980

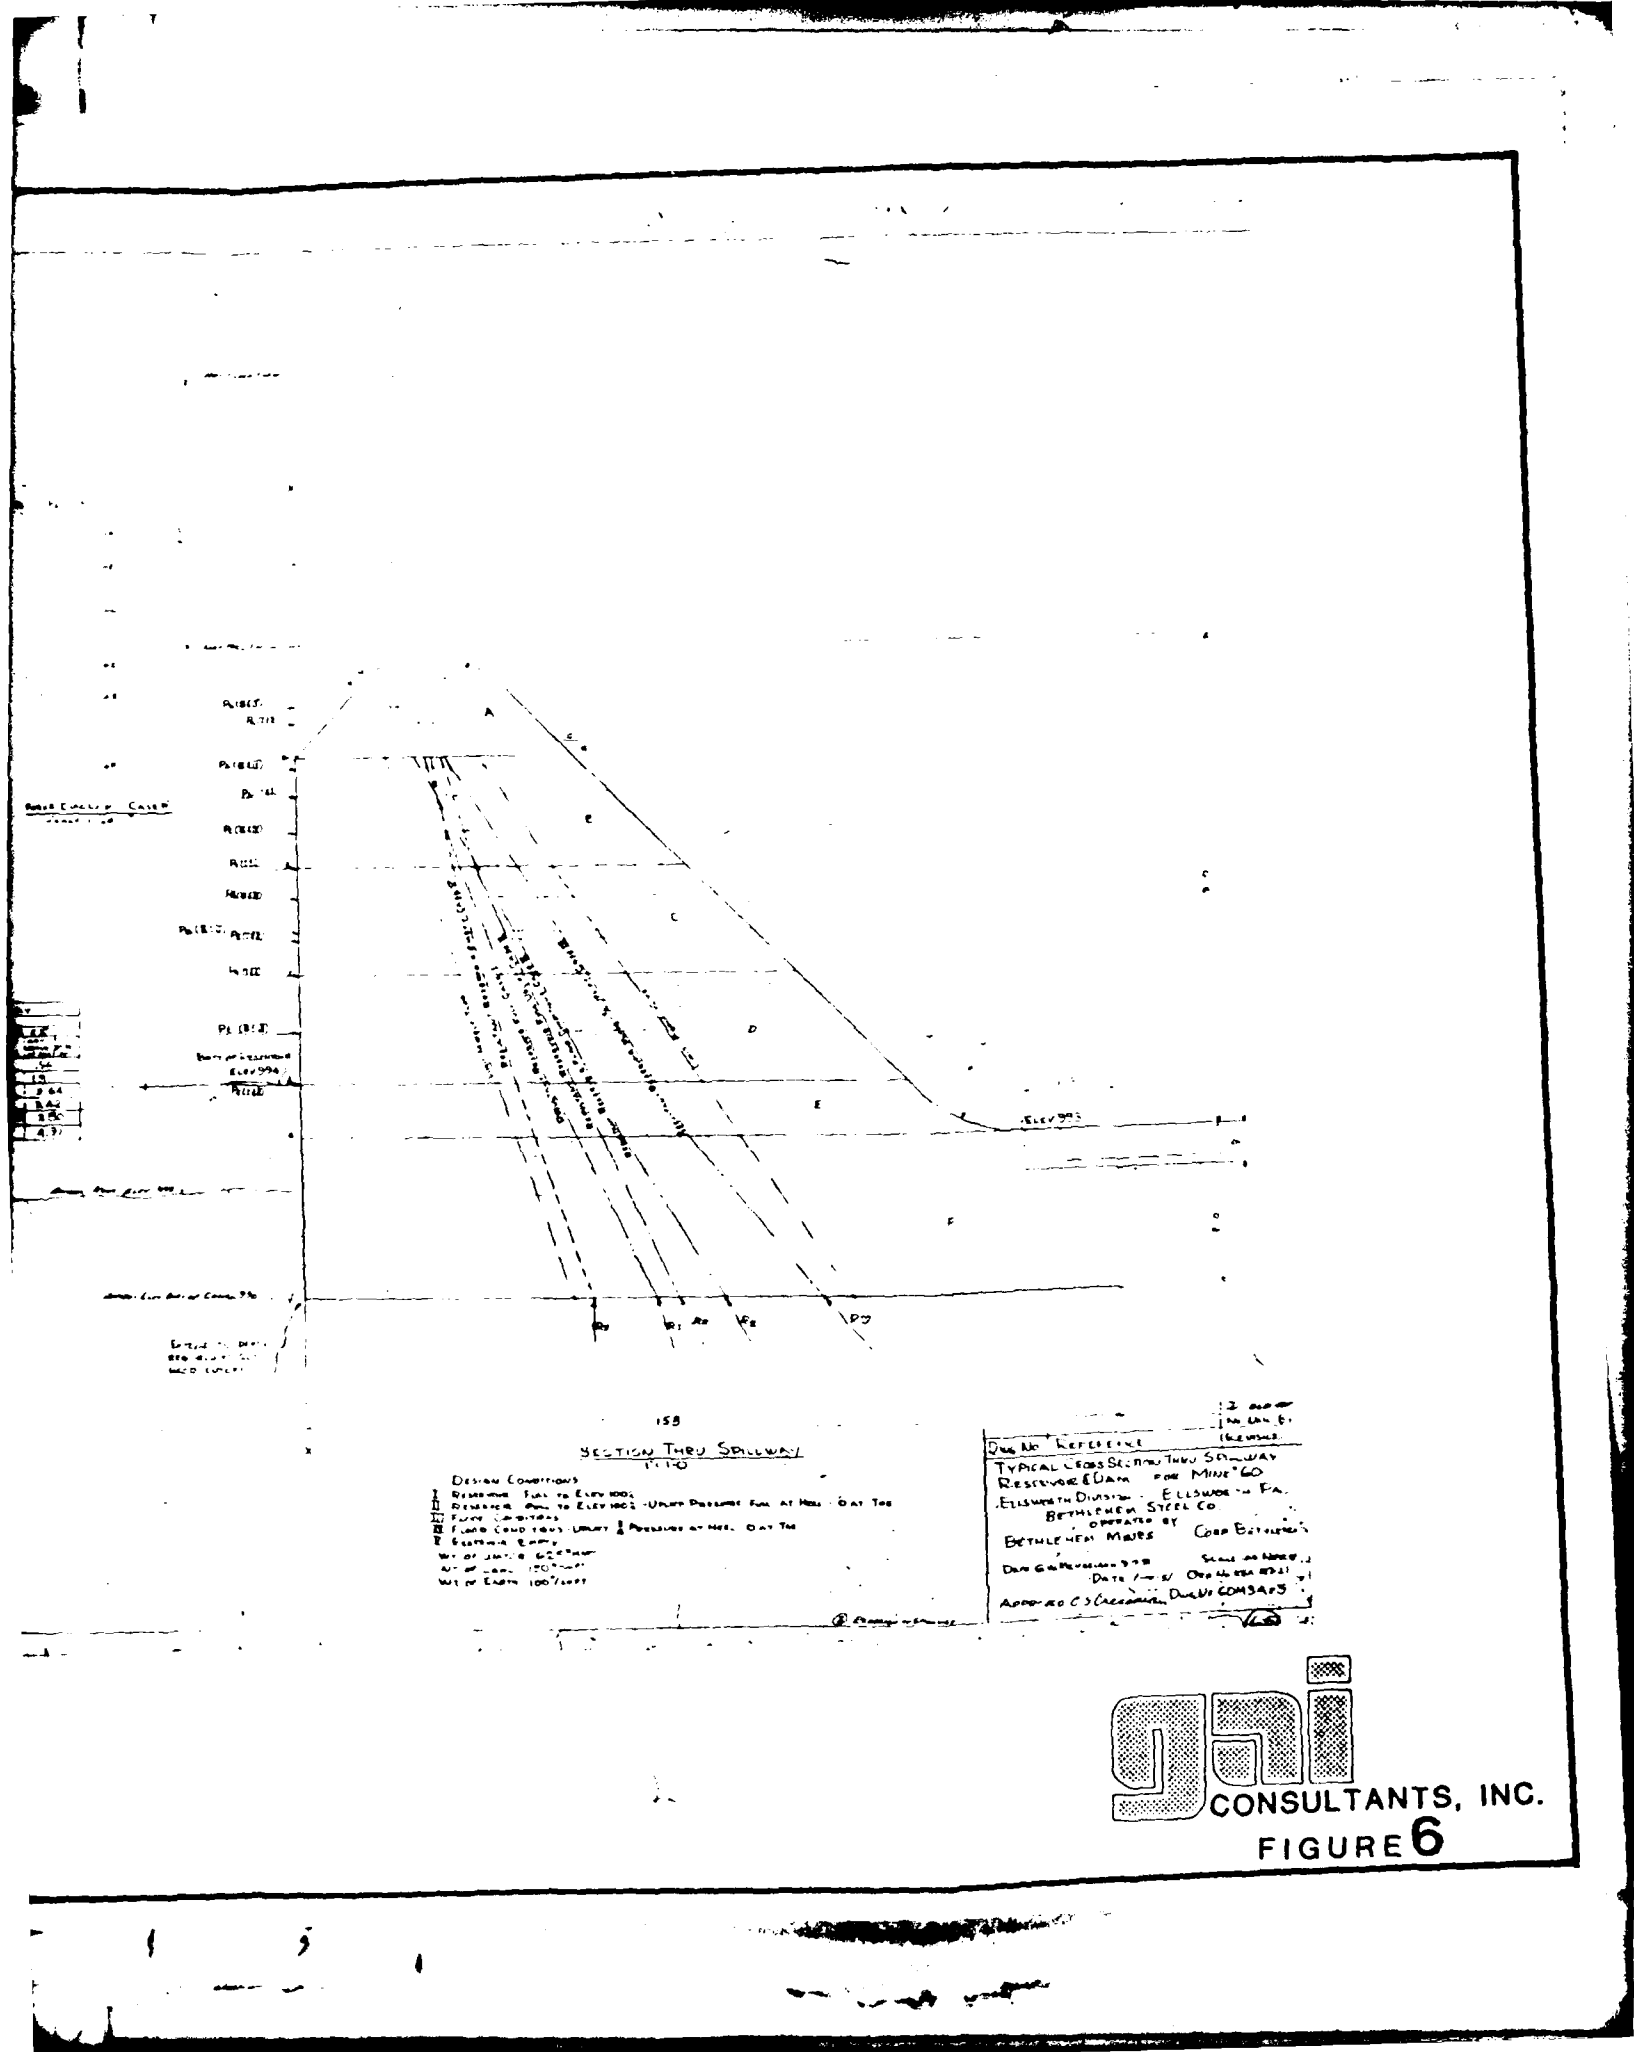
SECTION THRU SILLWAY

c. Specific Design Data and Criteria. Figure 6 shows a detailed spillway analysis for five reservoir conditions.

Results of the analysis (also shown on the figure) indicate that the design configuration is acceptable. Specifications for concrete mixes and fill placement are also presented in the notes shown on Figures 3 and 5.
